# BREWERY VESSEL COATING

ID: 7727

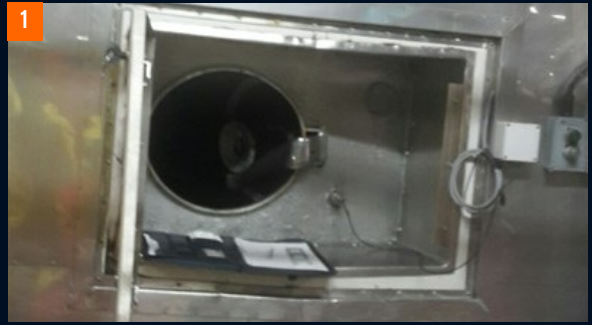
1 - Vessel manway

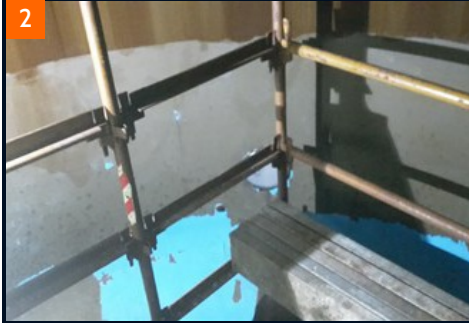
The original lining had started to break down. A corrosion resistant system that would not taint the final product was required. Dust was not permitted to escape the working area due to production going on in the surrounding area.

2 - Breakdown in original lining

The application was carried out in accordance with Belzona System Leaflet TCC-03. A sponge blast system was used to remove the failed lining & to prepare the underlying metal. Two coats of Belzona 5892 were then applied. The coating was post cured at 30 degrees C to comply with the WRAS potable water requirements.

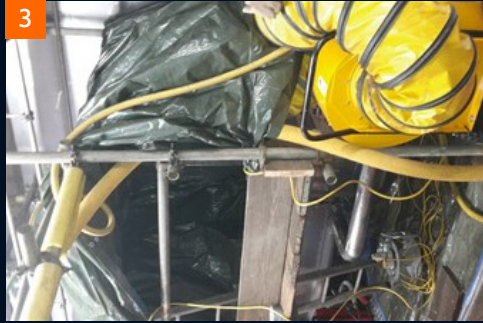
3 - Habitat to contain any sponge media from the blasting process

The works were completed in a short turn around & has extended the life of the vessel by many years. The sponge blast system & habitat keep dust down to the very low level required by production.

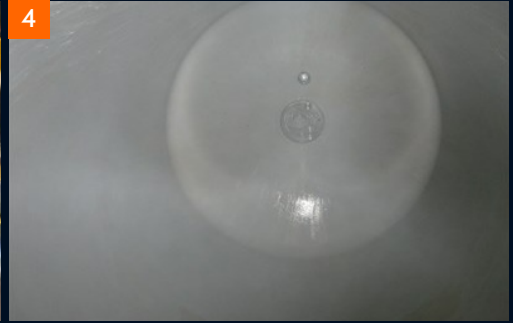
4 - Belzona 5892 applied
