# NUCLEAR PLANT BENEFITS FROM BELZONAS LONG-LASTING PUMP COATINGS

Main sea water cooling pumps.

Nuclear Power Plant - Flamanville, France

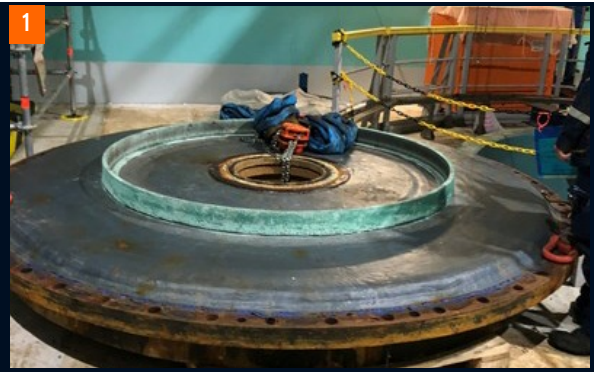
1. Pump removed from service for inspection 2. Inspection reveals the coating is still in excellent condition after 20 years 3. Coating frost blasted before application of Belzona 5821 4. Pump reinstalled with additional barrier protection

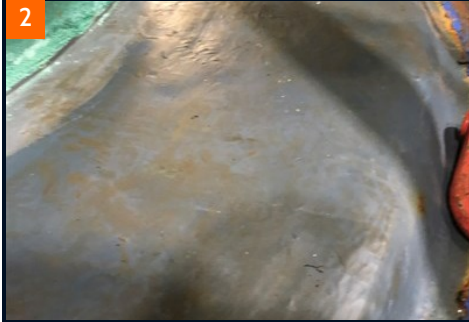
This power station had been coating cooling water pumps with Belzona for over 25 years, with each application demonstrating excellent erosion-corrosion resistance over that period. In this instance, the application was no different. Originally coated in 1998, the pump and coating were inspected 20 years later and found to still be in excellent condition. As a future-proofing measure, the Belzona Distributor frost blasted the coating and applied an additional layer of Belzona 5821 before returning to service. This high-performance system is ideally suited for equipment operating under immersion and erosive conditions and will extend the pump's life expectancy well beyond its original prescription.
