# INJECTION SAVES ROOFING MANUFACTURER TIME AND MONEY

ID: 7731

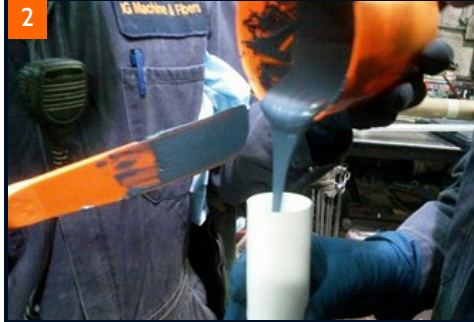
1. Damaged shaft with Belzona 1321 brush applied to the prepared substrate prior to forming technique.
2. Mixed Belzona 1321 being loaded into injection cartridge tube
3. Former showing vent ports whilst material is allowed to cure
4. Finished application with no additional machining required.

Belzona Know-How system leaflet MPT-2 for rebuilding damaged shafts using forming techniques was chosen for the repair. The application involves the manufacture of a suitable split former, which can be reused to repair additional shafts. The damaged substrate is prepared by a mechanical grinder and undercut a minimum of 1/16 inch (1.5mm), any contamination is removed with the use of Belzona 9111. Belzona 9411 was applied to the former prior to assembly. Belzona 1321 was then mixed in accordance with the IFU and loaded into an injection cartridge for injection into the former, air is vented out of the former ensuring that the cavity is filled 100% with no voids.
