# BELZONA 4111 REPAIRS SHELL AND SECURES WEDGE LINERS IN A BALL MILL

ID: 7732

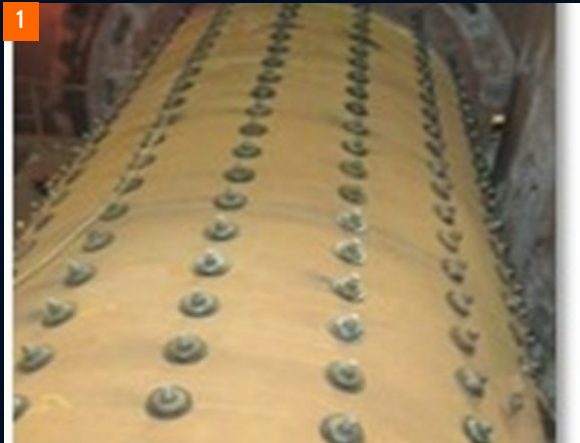
1. Ball mill, outer view 2. Ball mill, inner view 3. Shell repaired 4. Wedge liner secured

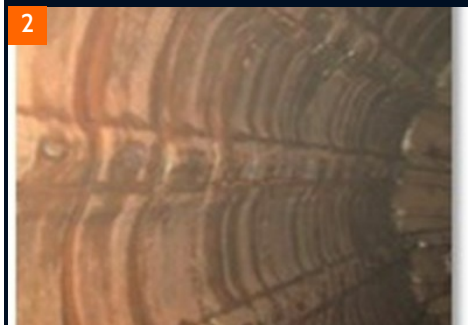
The wedge liners did not fit together perfectly. Overtime, they caused damage to and distorted the ball mill shell underneath. The refinery wanted to repair the damage and secure the wedge liners. The environment included bauxite and an alkaline solution at 80°C (176°F).
