# NUCLEAR PLANT BENEFITS FROM USING BELZONAS LONG LASTING PUMP COATINGS

ID: 7735

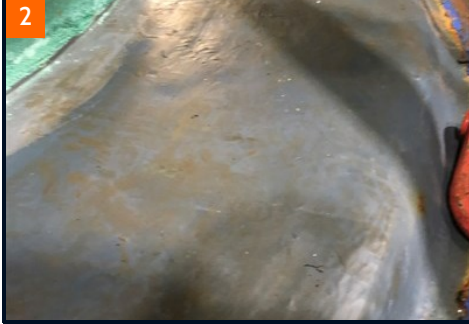
1. Pump removed from service for inspection
2. Inspection reveals the coating is still in excellent condition after 20 years
3. Coating frost blasted before application of Belzona 5821
4. Pump reinstalled with additional barrier protection

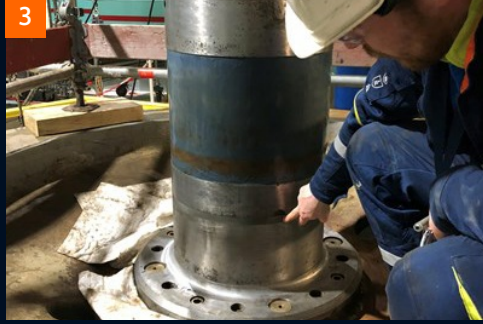
This power station had been coating cooling water pumps with Belzona for over 25 years, with each application demonstrating excellent erosion-corrosion resistance over that period. In this instance, the application was no different. Originally instated in 1998, the pump and coating were inspected 20 years later and found to still be in excellent condition. As a future-proofing measure, the Belzona Distributor frost blasted the coating and applied an additional layer of Belzona 5821 before returning to service. This high-performance system is ideally suited for equipment operating under immersion and erosive conditions and will extend the pump's life expectancy well beyond its original prescription.
