# BELZONA PUTS SCREW CONVEYOR BACK IN ACTION

Screw conveyor, displacing sugar beets

Sugar Mill, France

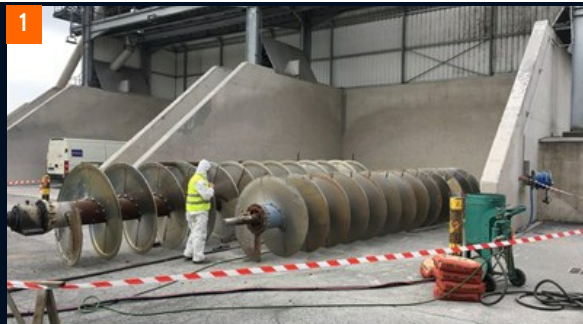
- 1 - Screw Conveyor
- 2 - Extend of the pitting
- 3 - Rebuilding of the pitted areas
- 4 - Belzona 1331 applied as a protective coating

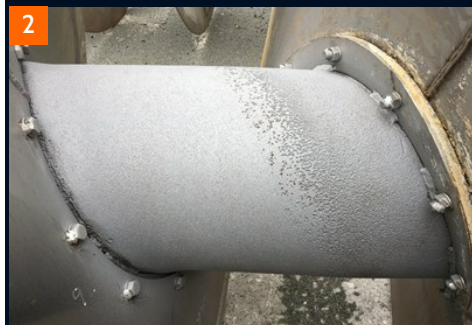
Erosion/corrosion caused pitting damage on the screw conveyor surface. Damage due to the beets as well as rocks and gravels.
