# BELZONA PROVIDES A SECOND LIFE TO THIS COOLING TOWER

External corrosion leading to significant wall thinning and localised through wall defects.

Heat Exchanger - acid cooling tower. Operating pressure of 1 bar and temperature between 30 and 50C.

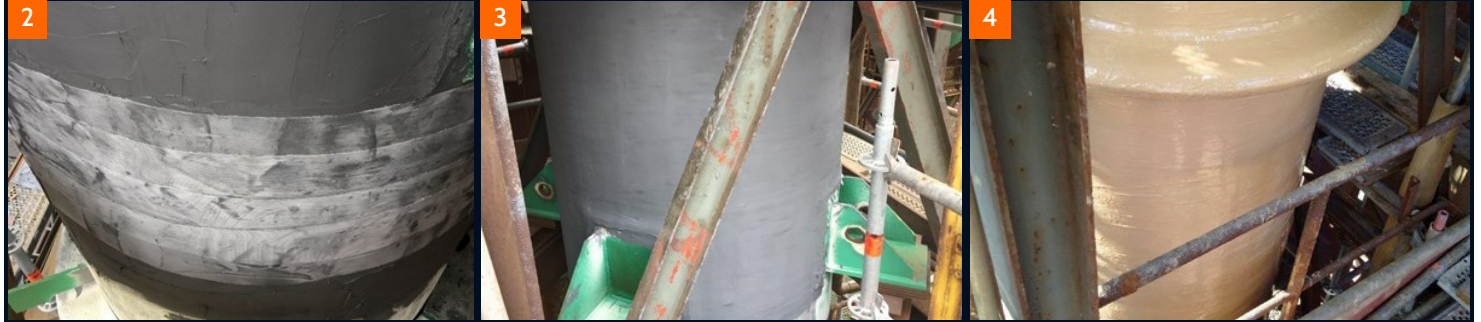
## PHOTOS

1 - The cold bonding of metal plate to patch up thin areas

2 - Wrap in progress

3 - Wrap completed

4 - Coating for further corrosion protection

Two towers were suffering from the same problem at the same time: through wall defects due to corrosion. The customer had one spare ready (costing 90,000€) but could not afford to wait for a replacement one being given the 8 months lead time. The Belzona repair was completed in 4 days by a team of 3 technicians. The tower was put back in service within 72 hours. The Belzona repair (products + application) did cost one-third of the replacement cost (30,000€).
