# BELZONA PREVAILS AFTER SEVERAL CAMPAIGNS OF PROTECTION FOR THIS AUGER SCREW

ID: 7739

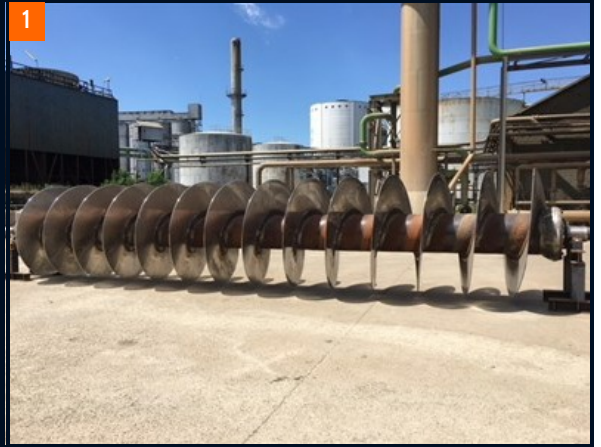
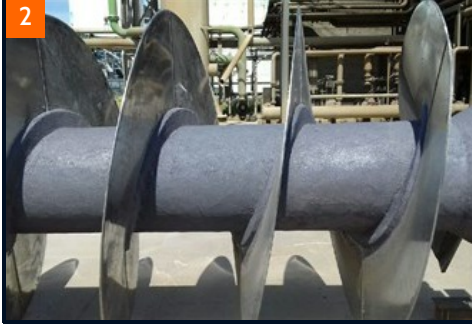
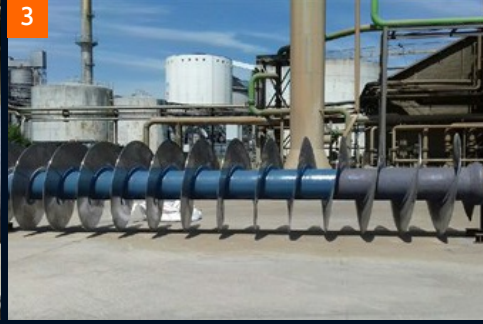
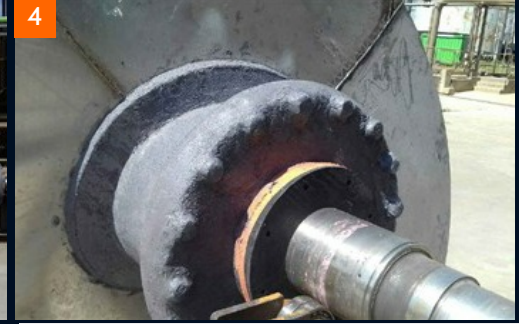
Wear due to continuous abrasion of the sugar beets as well as gravels, rocks and sand

Screw conveyor moving sugar beets across the plant

Application was carried out in accordance with Belzona Know-How System Leaflet SHM-14. Belzona 1812 was applied onto the first 3 metres of the screw for additional abrasion resistance.

This customer has recognised that by protecting his screws using Belzona, it could extend the life of the screw to last 5 to 6 years.
