# BELZONA REPAIRS PRIVATE RESIDENCE OUTDOOR POOL SKIMMERS

ID: 7740

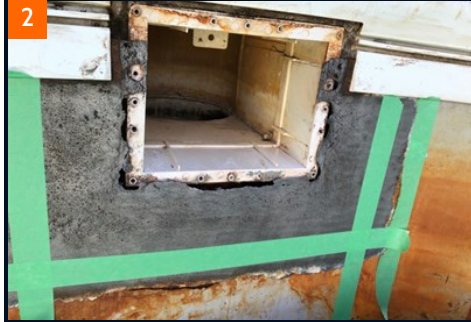
The customer was looking to do routine maintenance on the vinyl pool liner. When the liner was peeled back, there was heavy corrosion and metal loss on the steel backing plate around the skimmer housing areas. The customer wanted a Belzona solution to restore/repair the metal loss and prevent water from leaking behind the backing plate and skimmer housings.

Before photo showing extent of corrosion around skimmer housing.

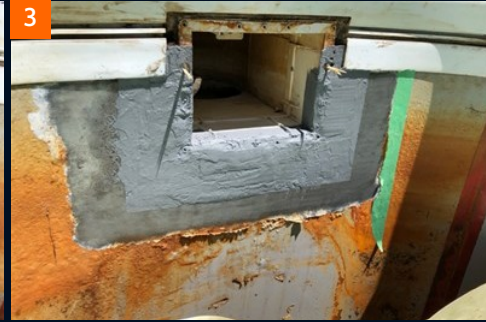
Repair area bristle blasted and cleaned.

6" around the plastic skimmer housing was marked to define the repair areas. These areas were bristle blasted to remove loose paint and rust, and to provide a suitable anchor profile. The repair areas were then cleaned with Methyl Ethyl Keytone (MEK) to remove all contaminants. The repair areas were re-taped 3" around the skimmer housings before beginning the metal repair. Belzona 1161 was then brushed into the steel substrate and plastic skimmer housings. Additional Belzona 1161, wetted into Belzona 9341 Reinforcement Tape, was used to re-build the metal loss and bridge the void between the steel backing plate and skimmer housings. Once Belzona 1161 was allowed to cure, Belzona 3121 (MR7) was applied over the entire repair areas, as two coats, preventing any future water ingress.

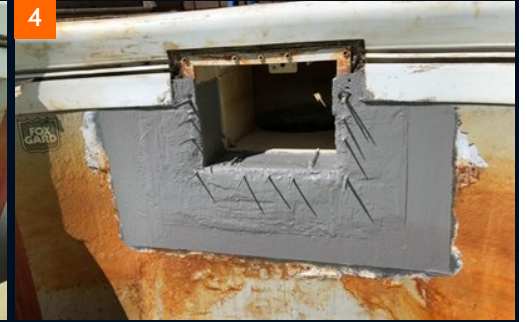
Belzona 1161 used to repair metal loss around skimmer housing.
