# BELZONA CUTS DOWN A CONCRETE SHIMMING APPLICATION TIME FROM 45 TO 7 DAYS

ID: 7741

A crane's base was seeing the heads of the bolts holding it down beginning to break off.

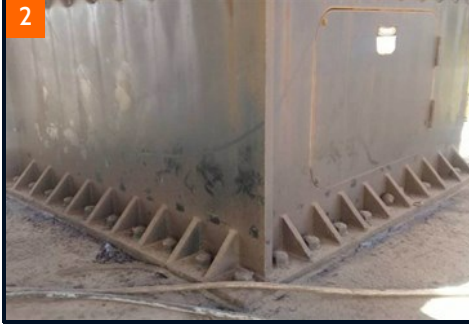
View of the Crane

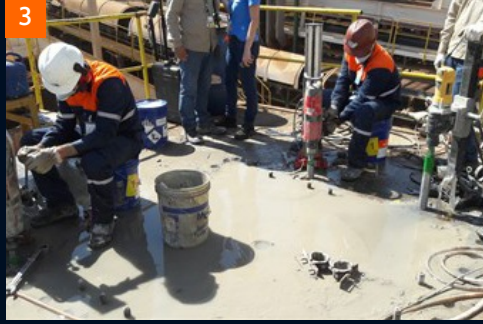
Due to constant movement and vibration created between the skid and the concrete foundation, the heads of the bolts holding the base down started to break off.

Concrete foundation before

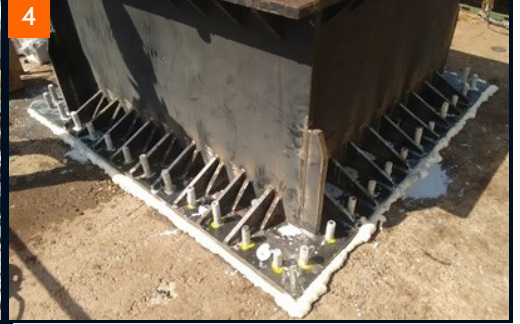
Application in progress including new anchor holes being drilled

First, 48 new holes were drilled to install newly fabricated bolts. Then the skid was positioned over the concrete base, secured and aligned with 4 metal bars in 4 points around the perimeter of the skid, and positioned on top of the concrete base. Belzona 4111 and Belzona 4151 were then mixed and injected into each of the holes. Anchor bolts were inserted, and excess of product was used to fill the annular space under the equipment.

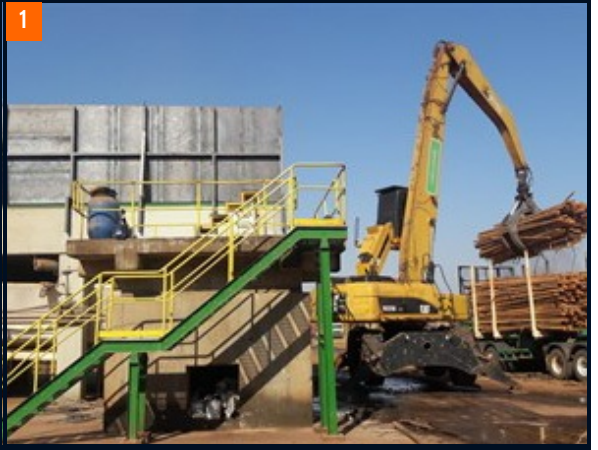
Completed application

A traditional approach to problems like this one would require at least 45 days to demolish the base of the crane and reconstruct it again. Whereas the Belzona solution came at half the cost of the traditional method and promised to return the crane back to service in 7 days. The customer was very impressed with the application and one year later reported that the bases were in perfect condition.
