# BELZONA REPAIRS AND PROTECTS BOW THRUSTER

ID: 7744

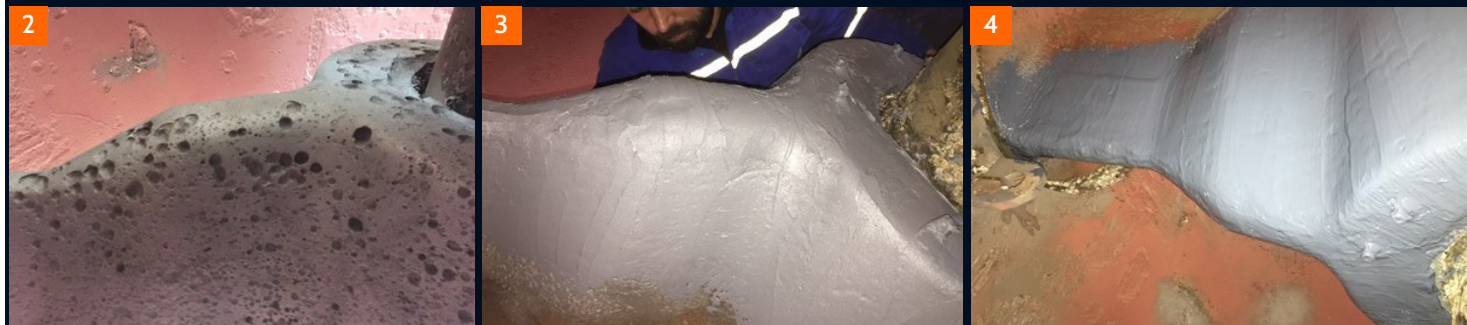
The bow thruster body was showing severe erosion and corrosion damage due to the marine environment.

1- Severe damage clearly visible on bow thruster body.

Ship was scheduled to leave the dry dock within 2 days. Immediately following surface preparation, Belzona 1111 (Super Metal) was applied to repair the pitted surface. A great advantage of Belzona 1321 (Ceramic S-Metal) is that it can be applied within a few hours on top of Belzona 1111 (Super Metal), without the need for further surface preparation. The work was completed within 5 hours. Belzona 1321 (Ceramic S-Metal) has a relatively short curing time until it is suitable for immersion, giving an added advantage, as it allowed a quick return to service.

2- Close-up view after successful grit blasting.

3- Repair of damaged surface with Belzona 1111 (Super Metal).

4- Coating of the surface with Belzona 1321 (Ceramic S-Metal).
