# BELZONA PROTECTS STEEL JOINTS ON LARGE SUSPENSION BRIDGE

ID: 7745

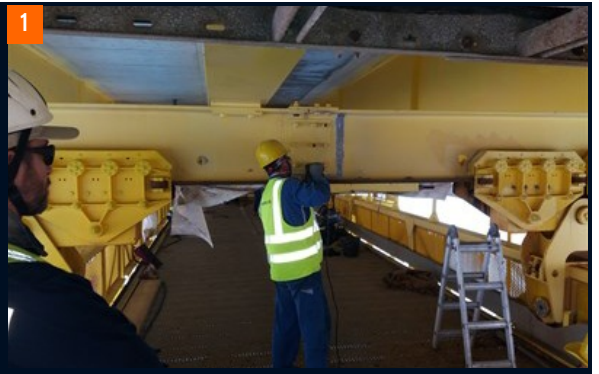
1. Preparation being carried out
2. Preparation completed
3. First coat of Belzona 3412 applied
4. Completed application
