# HEALTH DISTRICT HVAC TUBE SHEET REPAIRED WITH BELZONA

ID: 7753

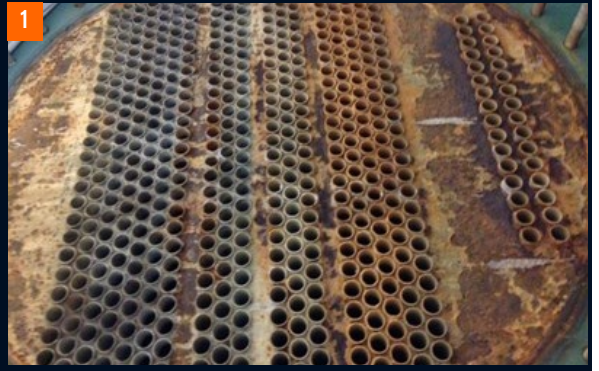
The tube sheet was severely corroded.

Corroded tube sheet before application.

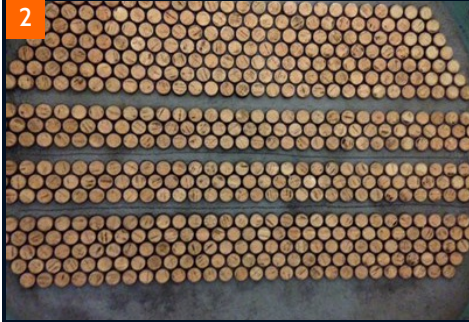
Tube sheet after blasting.

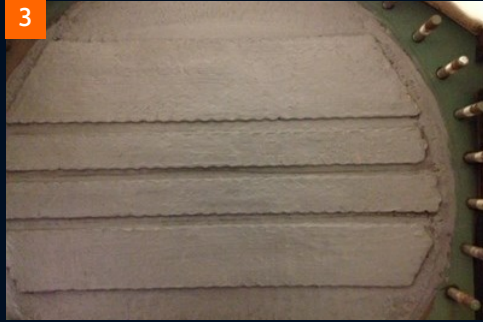
Belzona 1111 application onto the tube sheet.
