# FAST REPAIR OF BUTTERFLY VALVES WITH BELZONA ELASTOMERS RETURNS VESSEL TO SERVICE ON TIME

ID: 7754

Two butterfly valves that control the flow of seawater in a vessel. The valves needed to be repaired to return the vessel to water on time.

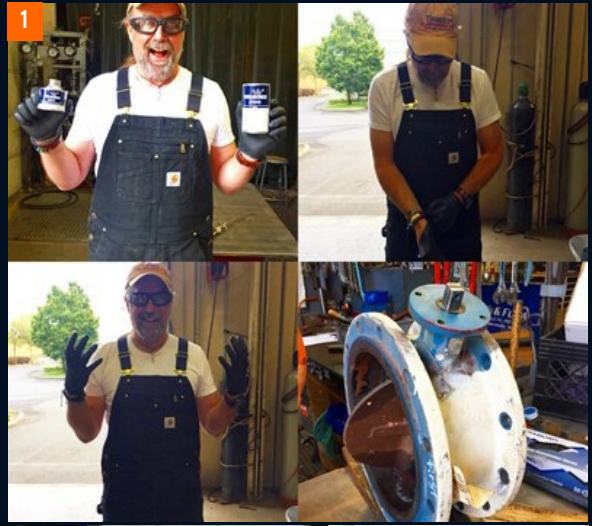
1. The Customer was excited to use Belzona to complete the repair.
2. Valve 1 with a large piece of rubber boot missing after surface preparation.
3. Valve 2 with damage on the seating area after surface preparation.
4. Repaired valves.

A modified version of Belzona System Leaflet VPF-3 was used to repair the valve lining. Loose material was removed and rubber substrate was undercut to avoid a feathered edge. Application area was thoroughly degreased to remove contamination. Steel substrate was ground and rubber substrate was abraded with roughening brush to create a surface profile for Belzona 2121 (an ABS approved product) to achieve a mechanical bond. The surface was then conditioned with a light coat of Belzona 2911 and allowed to cure. The areas of concern were then masked off and then Belzona 2121 was poured into place. The masking tape was removed immediately and the product was left to cure. After the product had cured the repair areas were machined back to tolerance.

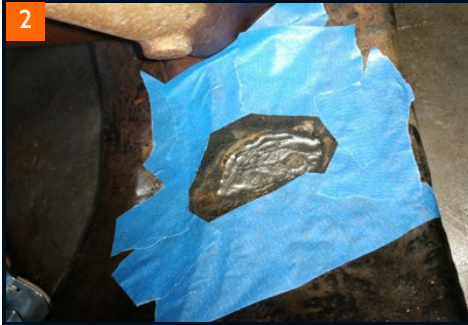
Two valves were damaged as the rubber boot that provided the sealing surface had suffered damage. One appeared to be damaged by debris that was in the way while the valve was closed removing a large piece of rubber material. The other valve was damaged at the seating area probably during installation.
