# A SHOWER AT A MINE MADE SAFE WITH BELZONA

A shower room at a live-in camp at a mine in Alaska.

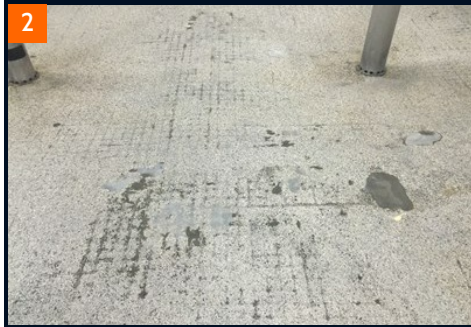
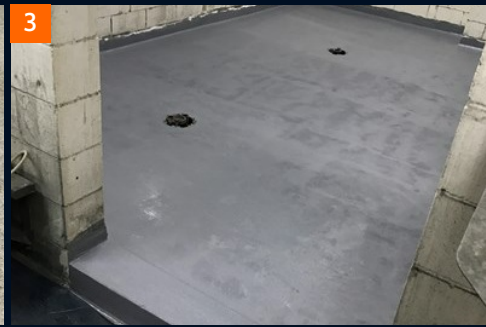
Originally, the floor was tiled. Eventually, it was damaged and an epoxy coating was used. It did not last too long before it began to flake off.

1. Shower in original condition.
2. Shower in original condition.
3. Application is complete.
4. Application is complete.

The application was carried out in accordance with a modified version of FPA-1 System Leaflet. The entire floor was prepped with a concrete grinder. The existing epoxy was removed, and the surface of the concrete was smoothed off leaving clean fresh concrete. Belzona 4911 and 4111 were applied over the entire floor to smooth off the irregularities and fill in the damage that was present from where the grout lines were with the original tile. Once that was completed, Belzona 5911 was applied with a semi-fine alumina oxide aggregate to provide a safe slip-free floor. Following the Manufacturer's Instructions For Use, Belzona 5111 was applied in two coats, first white, then gray as the Customer chose.
