# BELZONA PROTECTS DESALTER FROM CORROSION

ID: 7758

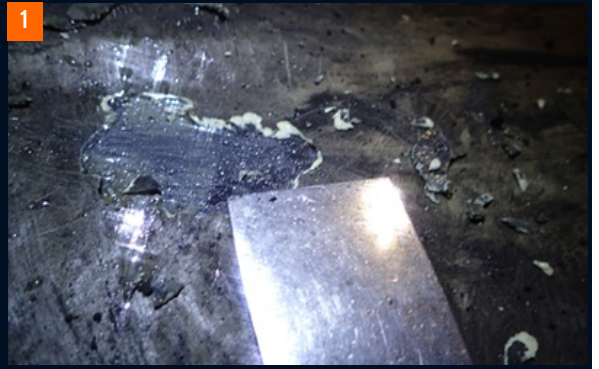
Two desalters had come out of service. Osmotic blistering had been noted on the previous coating within the vessel. A long term solution was required to protect the two vessels from corrosion.

Osmotic blistering in existing coating

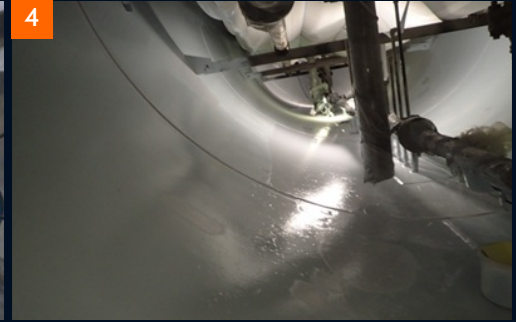
Two coats of Belzona 1523 applied by spray

The vessels were blasted to SA2.5 & minimum 75 microns using garnet. Salt tests were carried out to ensure the levels were within acceptable limits. Any pits found were filled with Belzona 1511. Hard to spray areas were stripe coated with Belzona 1593. Two coats of Belzona 1523 were then applied. The application was carried out in accordance with Belzona System Leaflet TCC-5.
