# BELZONA 1212 SEALS A LEAK ON A WASTEWATER HOLDING TANK

Sub-level wastewater lift station with a concrete holding tank.

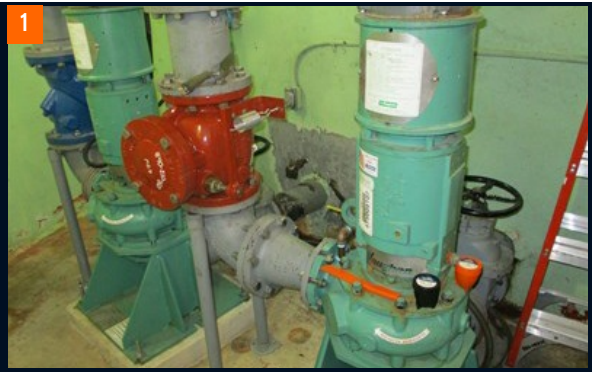
Sub-level wastewater lift station pump room.

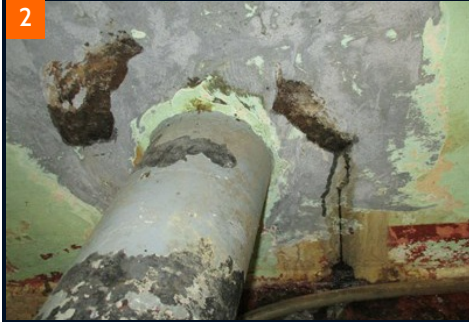
When the pipes were installed through the concrete wall, a grout was used to seal the area around the pipe. After many years of use, the grout began to fail, resulting in raw sewer water leaking into the pump room.

Close up view of the leaking areas.

The application was carried out in accordance with TCC-5 Belzona System Leaflet. A grinder was used to remove the paint and the loose and damaged grout around the pipe. The leak was depressurized by lowering the contents of the concrete tank. The crack was explored until it became clear we were into solid concrete and had identified the exact location of the source of the leak. We discovered the raw sewer water was coming through on the bottom right area, but was splitting and coming through the wall there, as well as coming through the wall in the top left area. Both areas were packed full of Belzona 1212 and smoothed over so the Customer could repaint the wall later.

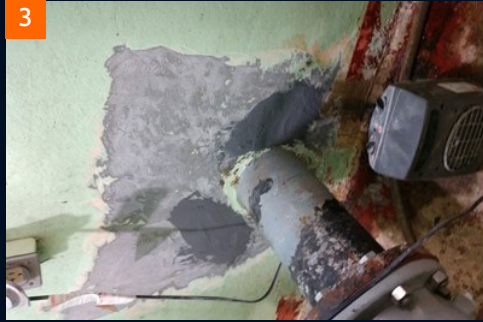
Belzona 1212 application complete.

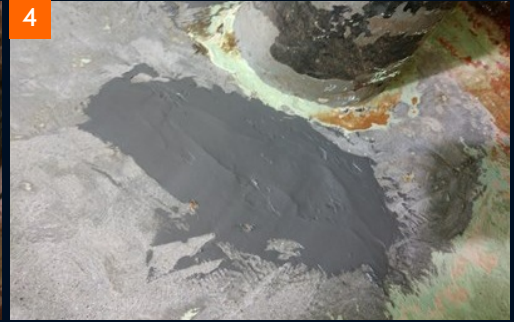
Close up of one area of the application.
