# BELZONA REPAIRS AND PROTECTS GAS STATION CONCRETE FLOOR

ID: 7761

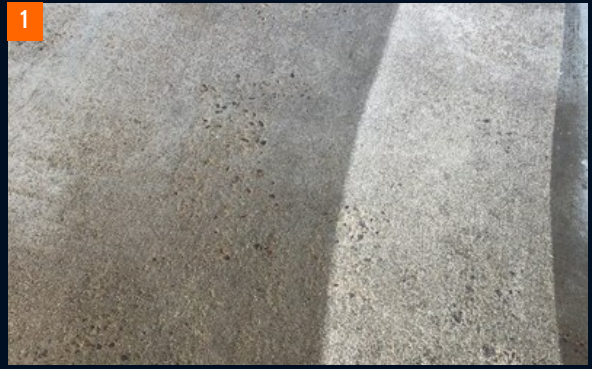
The concrete floor of this gas station was damaged, greasy and slippery.

1- Damaged and slippery concrete 2- Grit blasted concrete 3- Resurfaced concrete with silica 4- Final result with Belzona 5811
