# BELZONA SUPER METAL RESTORES STRUTS ON A DREDGING VESSEL

ID: 7762

Struts supporting propulsion system and housing cutlass bearings on 200 foot dredging vessel.

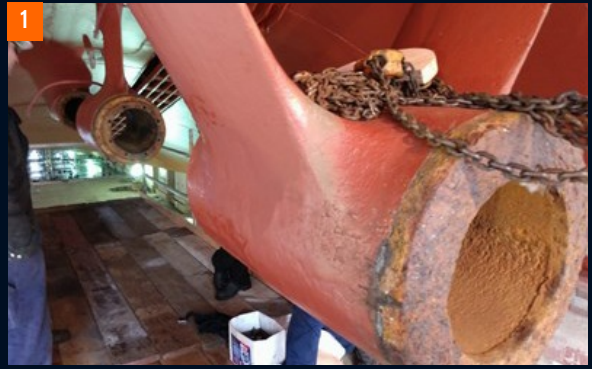
The internals of all 4 struts had suffered erosion and corrosion from seawater and needed to be restored.

2 of 4 struts that needed restoration

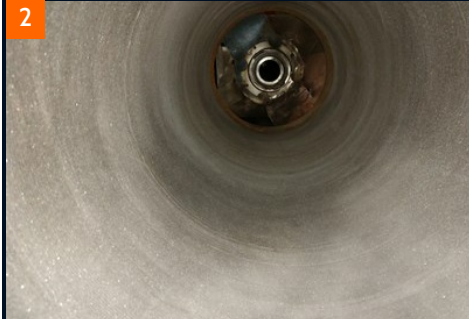
A clean, solid, roughened substrate

The application was carried out in accordance with SOS-9 BelzonaKnow-How System Leaflet. The substrate was machined down via boring to achieve a clean, solid substrate free of any corrosion. Substrate was then blasted with an angular grit to give a minimum surface profile of 3 mils. Substrate was then power washed with HoldTight 102 to bring salt contamination to acceptable levels. Belzona 1111 was then mixed and applied to build up the surface proud and then once cured, machined back to tolerance.

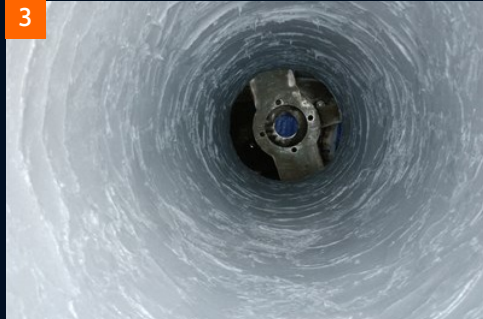
Surface built up with Belzona 1111

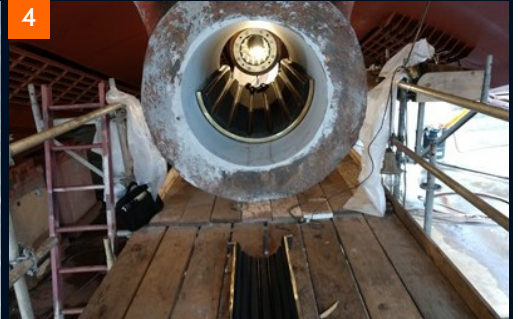
Completed application ready for cutlass bearings
