# EXPANSION JOINT REBUILD DONE RIGHT WITH BELZONA

ID: 7763

Hospital construction joint.

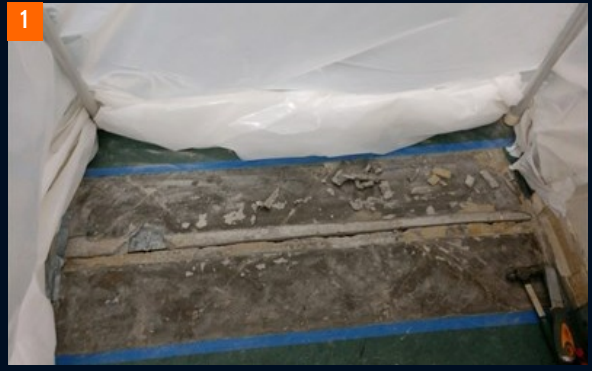
This was a construction joint from when the hospital was expanded. No expansion joint was installed, it was just concrete against concrete. Over the years the expansion and contraction caused the concrete at the seam to break and crumble. The metal and rubber expansion joint strip mounted over it also caused a bump in the floor.

1. VCT tiles removed and damaged concrete being removed. Notice the large area broken out on the left side.
2. Applying the Belzona 4111 on either side of the former.
3. Ready to pour the Belzona 2221, waiting for the Belzona 2911 to cure.
4. Tape removed. Completed successful application.

The original VCT flooring tiles were removed from either side of the seam. The loose and broken concrete was removed. The remaining concrete was ground back to open up space between the two sides. Belzona 4911 and 4111 were applied with the use of a plastic wrapped former to leave a nice squared, even area for the expansion joint to be created. The new full sheet vinyl flooring was then installed over the new joint and allowed to cure. A week later we came back and cut the vinyl flooring to expose the space between the concrete sections. The Belzona 2911 was applied and allowed to cure according to the Instructions For Use. Foam backing rod was inserted to a depth that was equal to half the width of the joint. Both sides were carefully taped off and the Belzona 2221 was then mixed and poured into the joint. Using a Belzona applicator, the excess Belzona 2221 was scraped off leaving it level with both sides of the new vinyl flooring. The tape was then removed and a bridge was placed over the joint to allow for hospital beds, carts, and staff to pass over it during the cure time. After 24 hours, the bridge was removed leaving a nice smooth, clean transition.
