# BELZONA PROTECTS COOLING TOWER BASINS FOR A SUGAR REFINERY

ID: 7764

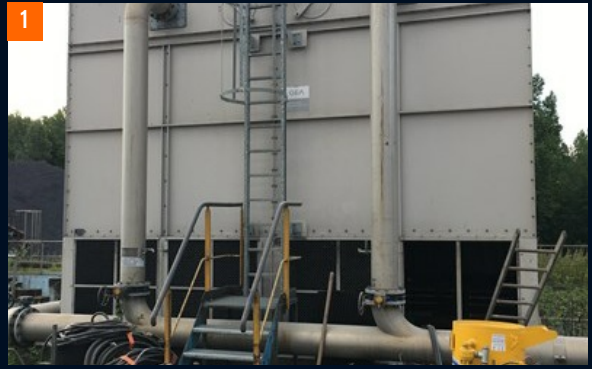
After an audit, the company was asked to check that their cooling basins were in good shape. They realised that a few of them needed to be fixed. The concrete was disintegrated and the resin (not a Belzona resin) that had been applied a few years ago was not efficient anymore and this required removing and replacing.

1- Outside view of the tank 2- Blasted pole inside the basin 3- Final application 4- Zoom on the final application

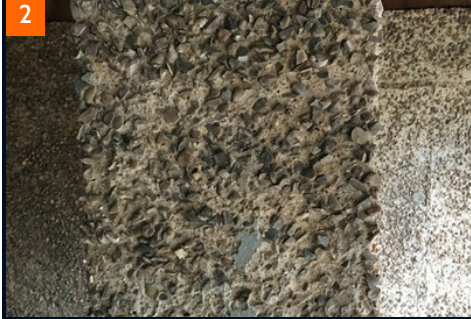
The cooling basins used in this refinery were attacked by chemicals: bleach and anti-corrosion agents which are usual additives for industrial cooling waters.

The concrete was prepared by sand blasting, Belzona 4111 with Belzona 4151 was used to repair and resurface the cracks then the basins were coated with 5811 for chemical protection in accordance with Belzona Know How system leaflet TCC-9 + TCC-15.
