# BELZONA REPAIRS LEAKY PIPES FROM A HEAT EXCHANGER

ID: 7765

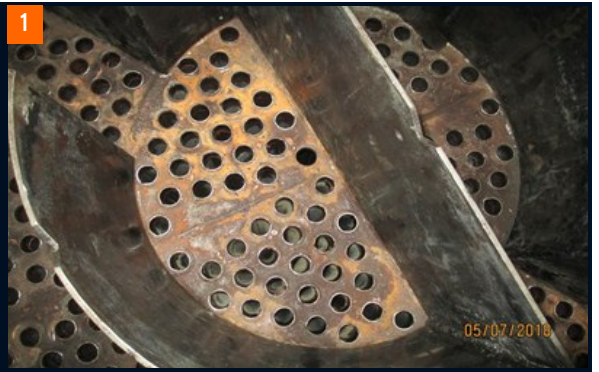
Sealing problem between the tubes and the tubular sheet on these heat exchangers due to a bad tube expansion, 50% of the tubes were leaking.

1- View of the equipment before application 2- Final application

The tubular sheet and the tube ends were grit blasted and cleaned with Belzona 9111 (Cleaner Degreaser) . Belzona 1111 (Super Metal) was used to rebuild the profile between the tubes and substrate then Belzona 5892 was applied on top for further protection against aqueous solutions. The application was carried out in accordance with a modified version of HEX-1 followed by HEX-3 Belzona System Leaflet
