# BELZONA REPAIRS AND PROTECTS THE ROOF OF STORAGE SILOS

ID: 7766

Asphalt coated roofs of four storage silos.

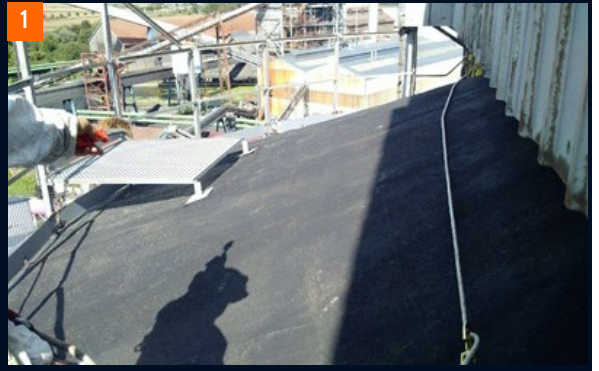
Previous asphalt coating used for roof protection.

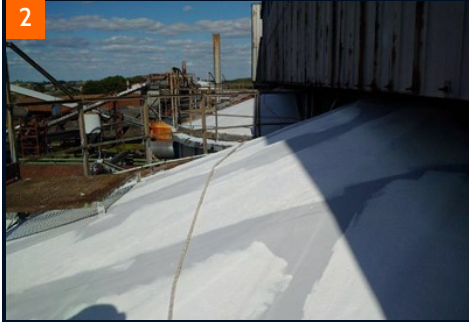
Belzona 3111 used on the previous coating welds.

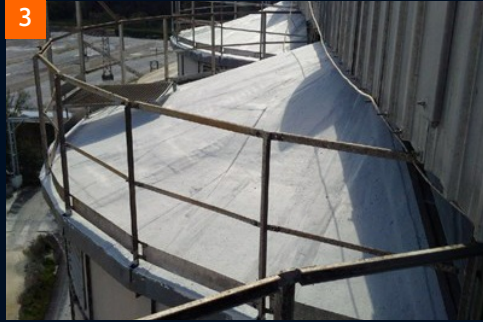
Final application.

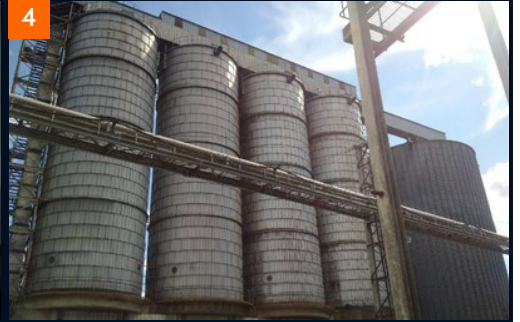
Overview of the silos.
