# BELZONA REBUILDS 112 YEAR-OLD YACHT HULL

Hull rebuilding on a 112 year old boat.

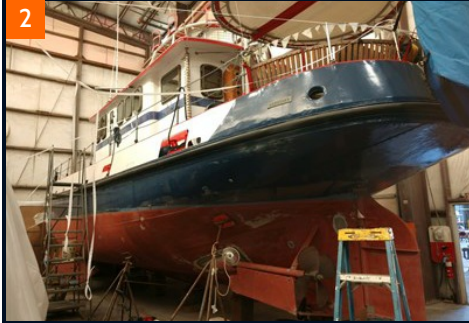
1. The Sarah Elizabeth Banks, formerly the SS Fire King
2. In dry dock, ready for repairs.
3. Port side hull application complete.
4. Port side propulsion area application complete.

The hull coating was removed and the application areas were grit blasted. The areas were then treated with Salt-Away to remove the impregnated salt from 112 years of sitting in saltwater. The areas were then blasted once again just prior to the application. Belzona 1151 Smoothing metal was mixed in several batches as there was one large area, and several smaller, detailed areas to work on. The Belzona 1151 was completely hand applied and finished using a Belzona applicator and a 10" steel putty knife. The Belzona 1151 was allowed to cure, and then over coated along with the rest of the hull with a standard hull coating anti-fouling material.

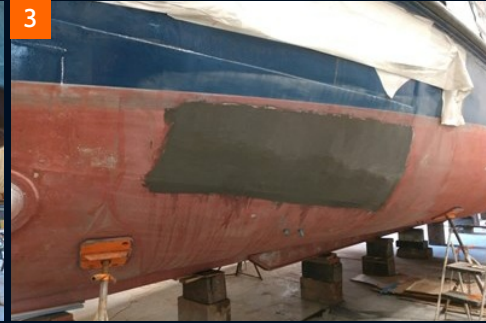
Several areas on the hull were corroding and getting thin. The front port side was thinning from wet/dry action due to being tied to a dock for a couple decades. The port side propulsion area was suffering from minor cavitation and erosion in the seam areas of the original riveted hull which had been filled with lead.
