# BELZONA PROTECTS THE INSIDE OF HOT LIQUOR TANKS IN A BREWERY

ID: 7771

Hot liquor tanks of a brewery, hot liquor is the hot water used to mash the ingredients to make beer.

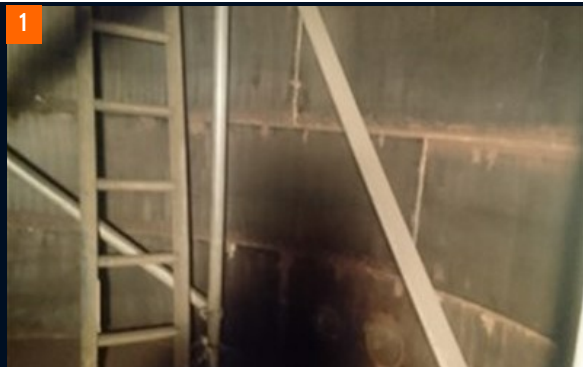
1- Blasted tank before application 2- Pit holes on the inside of the tank 3- Conditions inside the tank 4- Final application

The previous liner was removed by grit blasting, this step took 3 days. Once the pit holes under the liner had been repaired, two coats of Belzona 5892 were applied to the first two hot liquor tanks using Belzona Know How System Leaflet TCC-5. Belzona 5892 was cured with hot water and washed down twice.

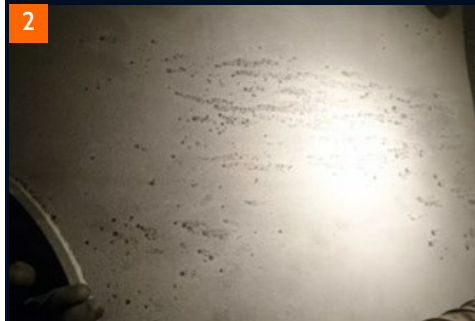
This brewery has 6 liquor tanks which operate at 85°C, they were all coated with an unknown liner which was failing. The location of the tanks meant that the client could not replace them and a high performance coating was required. The protective coating also had to have a potable water approval.
