# BELZONA REPAIRS TANK LEG SUPPORTS AT A DISTILLERY

ID: 7772

VAT tank leg supports at a distillery.

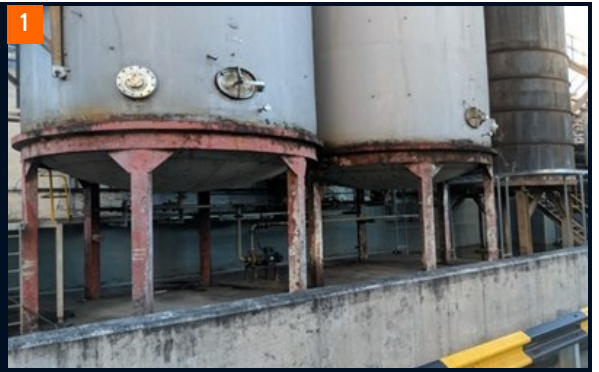
Several VAT tank leg supports were corroded due to the break down of the original paint system. Some tanks had already been condemned due to metal loss and through wall defects in the tank supports.

Damaged tank leg supports

The previous paint was removed by saturation blasting to keep the dust levels down on-site. The VAT legs were then coated by hand with Belzona 5811 in accordance with a modified version of Belzona Know-How System Leaflet TCC-5.

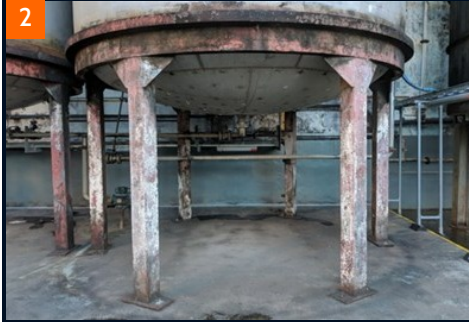
Damaged tank leg supports

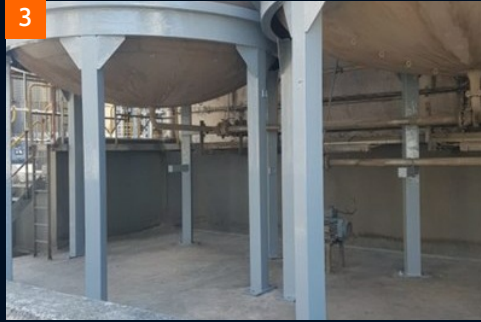
1st coat of Belzona 5811

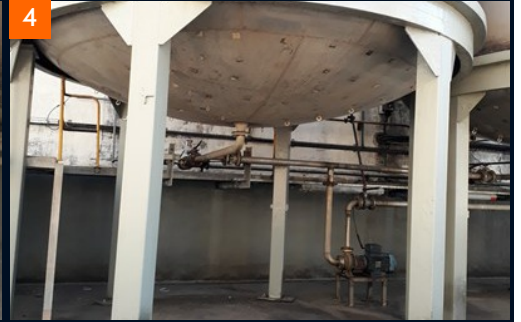
The application was re-visited 1 year later, and found to still be forming with no damage or repairs required.

Application after 1 year in service
