# BELZONA REPAIRS AND PROTECTS THE ROOF OF A GLASS FACTORY

ID: 7775

The roof of a perfume bottle manufacturer in North of France.

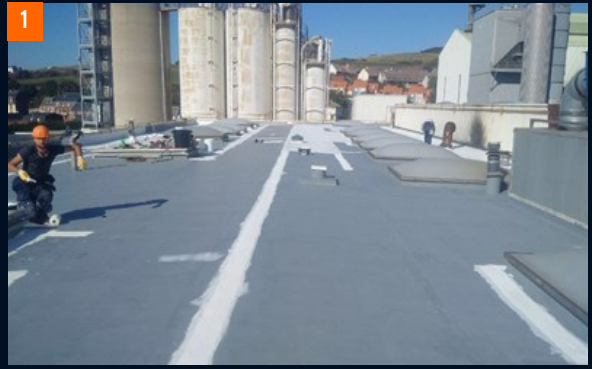
1. First step of the application using reinforcement sheets impregnated with Belzona 3111 on welds and junctions of the original EPDM membrane
2. First coat - Hand applied
3. Second coat - Spray applied
4. Final application

The whole roof surface was pressured washed, then Belzona 3111 was used with reinforcement sheets on the welds and junctions of the original EPDM membrane. After ensuring that all potential problem areas were encapsulated, a two coat system of Belzona 3111 was applied over the whole roof. The first coat was hand applied and the second one applied with an airless spray gun. In accordance with Belzona system leaflet RPA-01
