# A BELZONA "SMOOTH" OPERATION FOR A FAILING EXPANSION JOINT AT A MEDICAL FACILITY

ID: 7776

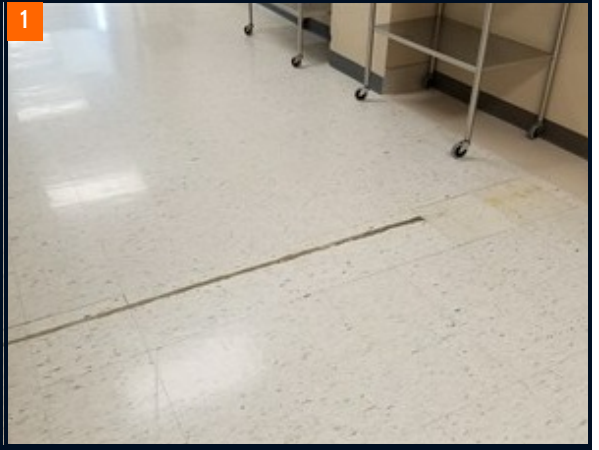
Existing damaged expansion joint.

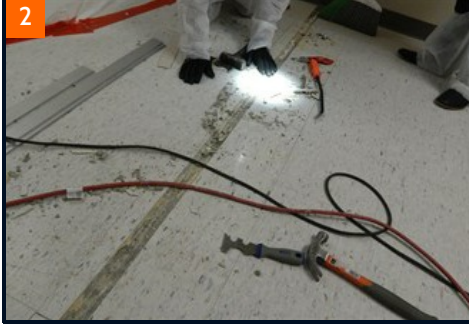
Removal of failing sealant and spalled concrete/tiles.

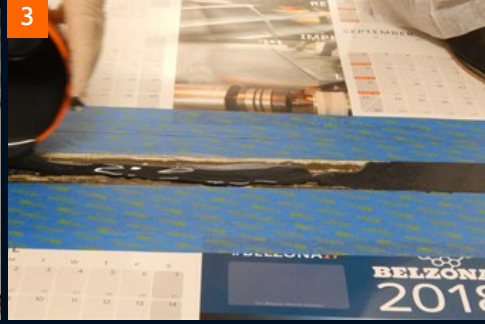
Pouring Belzona 2221.

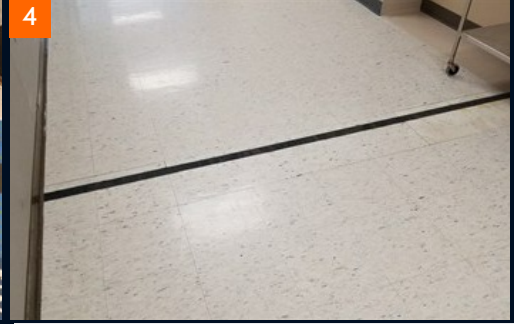
Application done, expansion joint ready for traffic.
