# BELZONA 1212 REPAIRS A WORN WASTEWATER LIFT STATION PUMP

ID: 7779

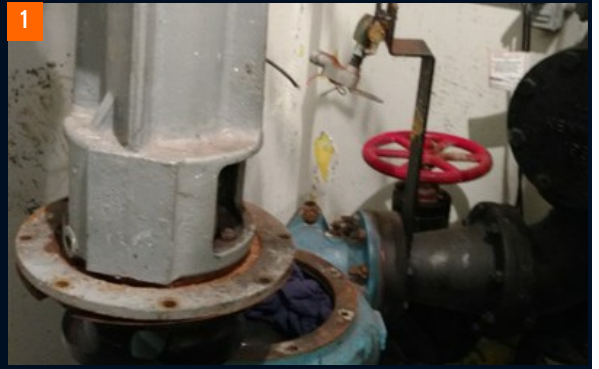
There was a hole worn underneath the impeller on the volute from "rags" in the wastewater system getting caught. This allowed for raw wastewater to leak from the pump into the underground vault which is located next to a large lake.

Pump ready for repair.  
Small hole visible.  
Belzona 1212 being applied.  
Completed application.

The top portion of the pump was lifted and pulled aside providing limited access to the problem area. A grinder was used to roughen the application area as best as possible and emery cloth was used to prep the areas that the grinder could not reach. A golf ball portion of Belzona 1212 was mixed and applied by a gloved hand to the hole and smoothed out so no further machining would be necessary. The water department crew left for lunch after the application, and then returned and reassembled the pump and returned the pump back to service. The application was carried out in accordance with Belzona Know-How System Leaflet CEP-5.
