# RESIDENTIAL ROOF REPAIRED BY BELZONA

ID: 7784

## PROBLEM

Rain water was pooling and penetrating under the roofing tiles. Several attempts were made with silicon and mastic materials to address the problem.

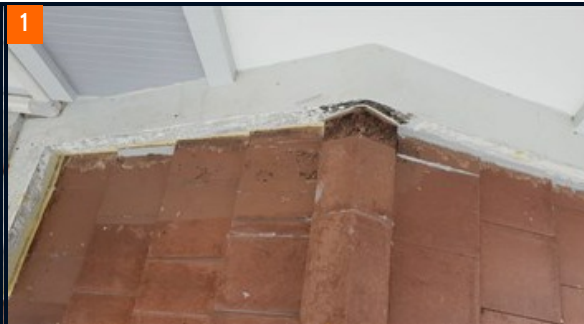
A residential building had an extension retrofitted, however water was penetrating between the house and the new roofing area.

Picture 1 - The roofing area  
Picture 2 - Rebuilding with Belzona 4141  
Picture 3 - Application of Belzona 3111  
Picture 4 - The completed application
