# BELZONA PREVENTS WATER PENETRATION INTO A DATA STORAGE FACILITY

ID: 7786

Steps at the entrance to a financial building.

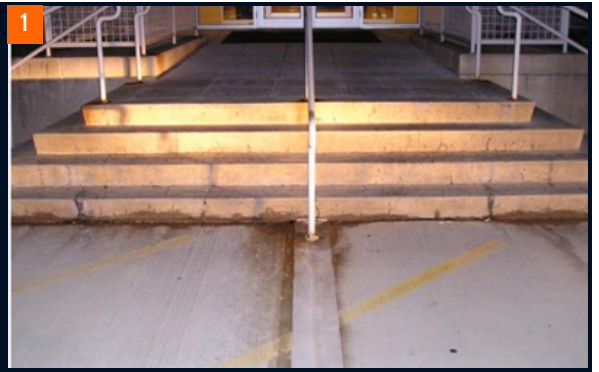
Spider cracks compromising the integrity of the staircase and allowing water to penetrate into the building's data center underground.

Showing Damage After powerwashing  
Completed application; the cracks filled,  
and the steps re-surfaced with Belzona  
4111 for a long-term protection

The entire repair was complete on a Saturday afternoon after employees vacated the building. The cracks were filled with Belzona 4111 and the entire surface was restored for waterproofing and a long-lasting protection.
