# DATA CENTER'S RTU AND MAU REPAIRED AND PROTECTED WITH BELZONA

6 Air Handler Package Units (RTU) and 1 Makeup Air Unit (MAU) located on a rooftop of a data center.

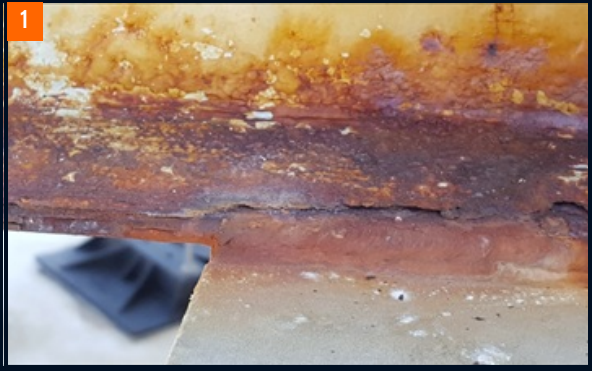
Corrosion and failing existing coating on steel infrastructure, disbanding of a sump “bedliner” coating system, controls room having excessive condensation. Although specified to have R-20 insulation value, the units only had R-6 insulation value when installed.

Showing damage on steel structure  
Steel structures repaired and protected with Belzona 5111 and Belzona 6111  
Cooling tower sump seams repaired with Belzona 3121 and protected with Belzona 5811  
Insulation installed and encapsulated with Belzona 3111

The steel structure was clean blasted to remove the loose and damaged particles. Achieving a white metal finish with a 3-5 mil profile. The surface was rebuilt where needed and coated with Belzona 5111 and 6111. The cooling tower sumps were first cleaned by removing the “bedliner”, the surface was then abrasive blasted. The leaks were repaired with Belzona 1121. The seams were sealed with Belzona 3121 and the entire surface was then coated with Belzona 5811 to provide a cohesive chemical and water-resistant coating. R-20 insulation was installed and encapsulated with Belzona 3111.
