# DATA CENTER'S ENGINEERING ROOM WATERPROOFED WITH BELZONA

ID: 7788

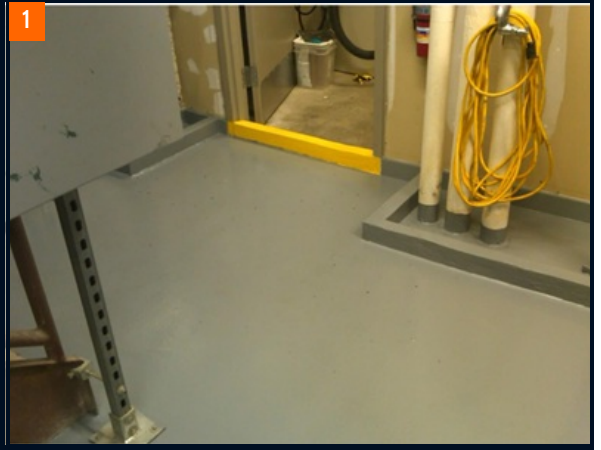
Threshold built with Belzona 4131 and made "safety" visible with Belzona 4411 Curbs around the piping built with Belzona 4131. The floor is coated with Belzona 5231 Application is completed

Belzona materials were used to install new curbs and thresholds and to provide a protective sealant to the flooring. Belzona 3121 was used to seal the areas between piping and the floor. The threshold at the door and curbs around the piping were built with Belzona 4131. To avoid a trip hazard and to ensure safety the thresholds were coated with Belzona 4411 Yellow. Then, the entire floor was coated with Belzona 5231 for chemical and water protection as well as to provide a non-slip and easy-to-clean finish. No more leaks jeopardizing the critical facility below.
