# HOSPITAL'S ENGINEERING ROOM EXPANSION JOINTS WATERPROOFED WITH BELZONA

ID: 7789

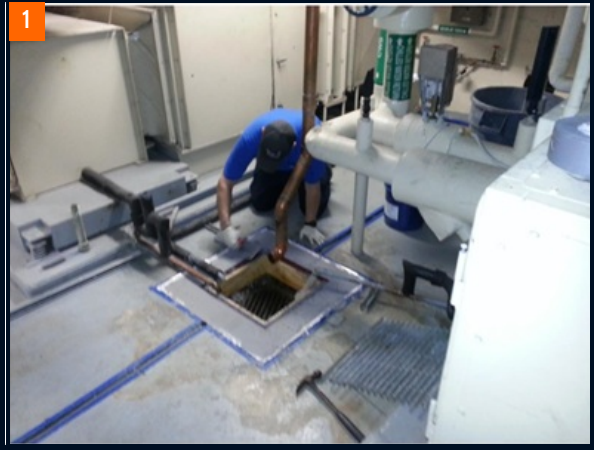
Concrete restoration with Belzoa 4111

First, the existing joint material was removed, and the concrete was restored with Belzona 4111. A new joint was installed using a foam backer rod and Belzona 2221.

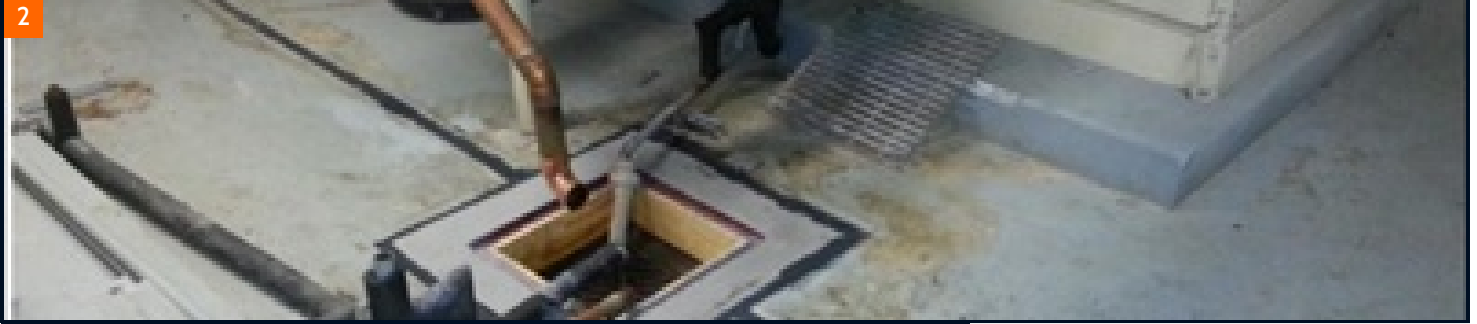
New joint installation with Belzona 2221
