# PROPELLER SHAFT PROTECTED WITH BELZONA COATINGS

ID: 7791

Marine vessel propeller shaft.

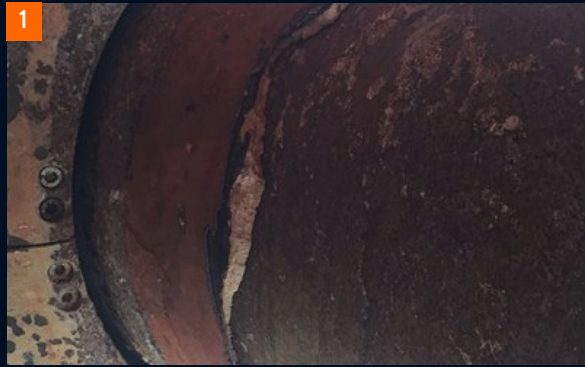
Previous coating had failed by delamination, causing the shaft body to corrode.

The failed coating and corroded shaft.

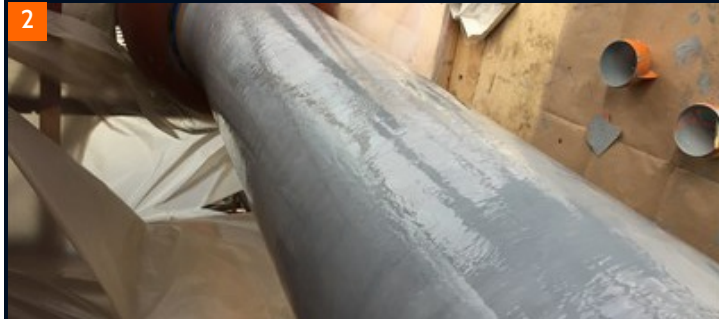
Shaft protected with Belzona 1341.

Application was carried out in accordance with a modified version of Belzona Know-How System Leaflet SOS-6.
