# COOLING WATER OUTLET PROTECTED WITH BELZONA 1321

ID: 7792

Sea water used as coolant in open cooling system in coal fired power station. Steel cooling water outlets below the condenser

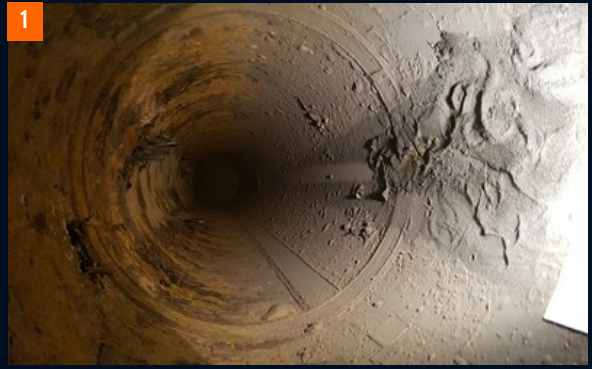
The existing rubber lining had reached its end of life. The existing rubber was no longer providing the steel pipes with protection from erosion/corrosion. The rubber needed to be removed to allow for application of Belzona 1321.

Rubber lining in outlet pipe

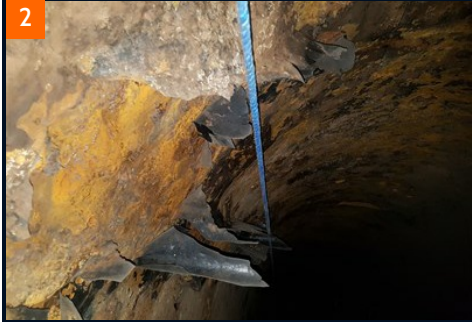
Condition of rubber lining

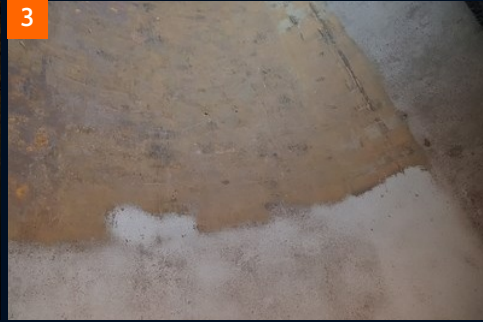
Blasting in progress

The rubber was stripped. The steel was grit blasted and then washed to removed all salts. The steel was blasted back to ISO 8501 SA 2 1/2 and Belzona 1321 was applied in two coats.

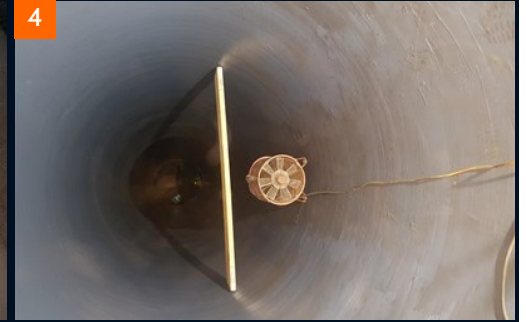
Finished Belzona 1321
