# AGITATOR PROTECTED FROM ACID ATTACK BY BELZONA

Agitator blades exposed to chemical attack and erosion in copper plant.

Andalucia, Spain

October 2018

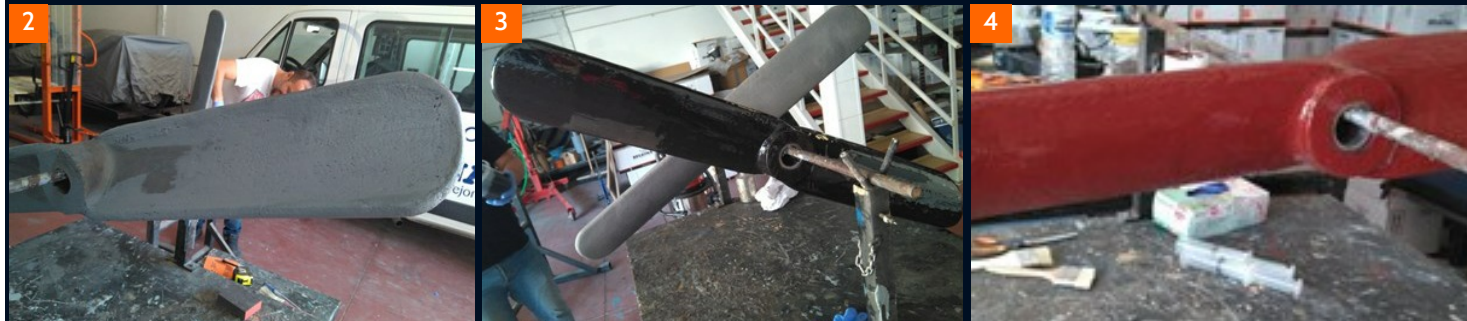
Concentrated sulfuric acid at elevated temperatures was causing deterioration of the agitator blades, which were being replaced every 4 months as a result.

1. Damage to Blades
2. Rebuilt with Belzona 1511
3. First coat applied
4. Completed application

Initially the customer believed that the problem was caused by erosion, due to the concentration of suspended solids within the fluid. They had tried a rubber coating to protect the blades, however the poor chemical resistance to the acid and temperature caused the rubber lining to fail quickly. It was concluded that erosion may not be the main cause of the damage, hence the customer wanted to trial a chemical resistant lining. As the conditions are 40% Sulfuric Acid at 80degC, Belzona 4341 is the best choice. An aggregate was incorporated into the coating to add some erosion resistance.

Belzona 1511 (Super HT-Metal)  
Belzona 4341 (Magma CR4)
