# UNDERGROUND SEAWATER PIPELINE SUPERWRAPPED WITH BELZONA

Underground section of a seawater pipeline as part of a cooling system for a refinery.

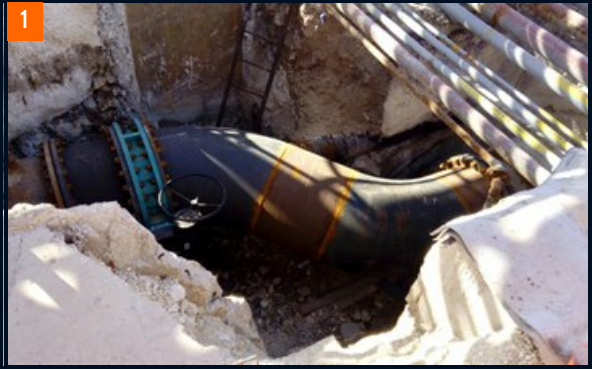
Internal corrosion of pipeline and initial stages of weld degradation has been observed.

Pipeline before repairs

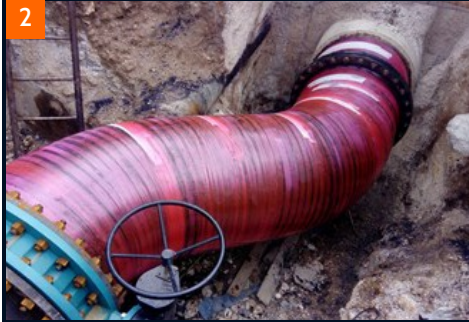
Belzona SuperWrap II system applied and consolidated

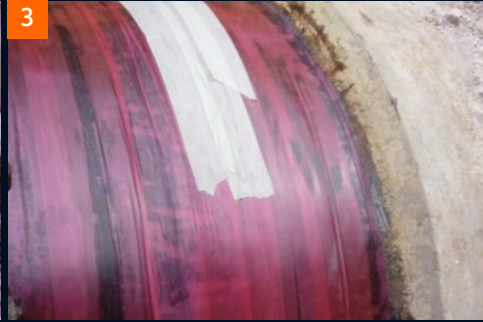
Interface with concrete
