# NUCLEAR HEX REFURBISHED WITH BELZONA

ID: 7797

Cooling system heat exchanger in nuclear power station.

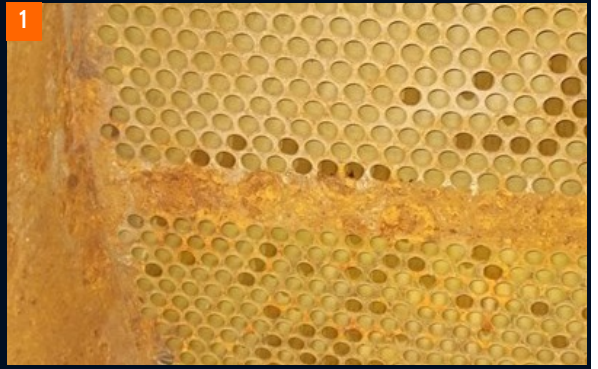
River water used for the cooling system had cause corrosion and pitting on the tube sheet of a heat exchanger.

- 1.) Corroded Tube Sheet
- 2.) Rebuilding with Belzona 1511 in progress
- 3.) Repairs completed with Belzona 1391T
- 4.) Close up of HEX after 18 months in service, still in perfect condition

The application was carried out in accordance with Belzona System Leaflet HEX-01.

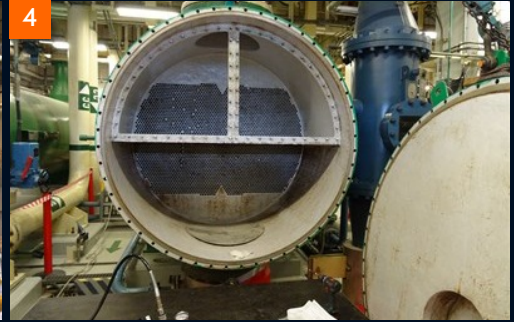
Replacement was the only alternative to the repairs, however this is very costly. Due to very high cost of downtime, the application had to be carried out within a short window. The local Belzona Distributor was able to offer a speedy repair due to their many years of application experience. The application required careful planning and a larger than normal work force. Only when the customer was satisfied that the application could be carried out within the time window were they convinced to proceed with the application instead of ordering a replacement. Heat exchanger inspected after 18 months of being service and still shown to be in perfect condition.
