# BELZONA PROTECTS A ROOF ABOVE TRANSFORMERS

ID: 7798

A roof made of steel and bitumen needed to be repaired and protected.

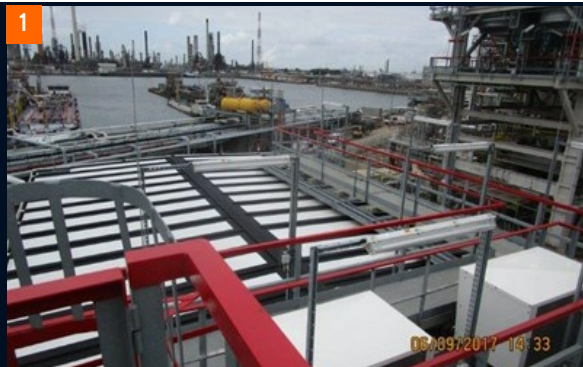
The roof had been protected with a bitumen coating, however, this was found to be unsatisfactory by the customer. As well as this, thanks to the building not being built to specifications, there were an estimated 160 perforations across the whole of the roof. This needed to be repaired and protected given the fact that the roof protects transformers and leaks could be very dangerous.

Overview of the roof before the application

The application began with the steel roof being cleaned with water and powder cleaner to remove all surface contaminants. According to a modified version of Belzona Know-How System Leaflet RPA-1, the surface was then manually roughened. A coat of Belzona 3921 Conditioner was then applied followed by a two-coat system of Belzona 3111 with a reinforcement sheet used in the first coat.

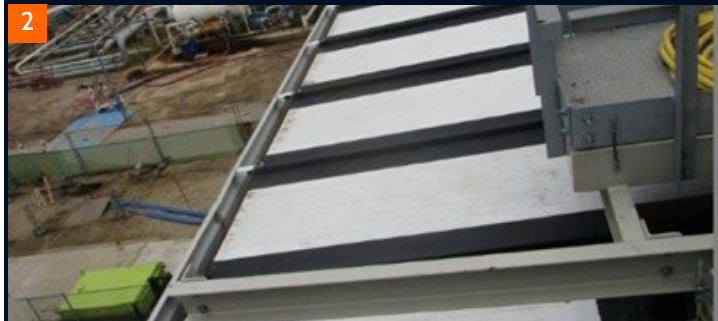
A close-up view of the roof before application

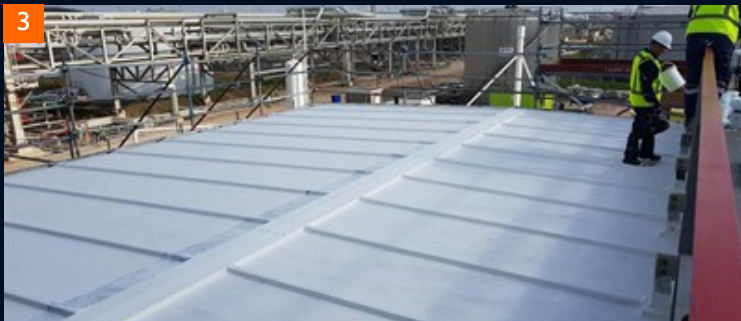
Final application
