# BELZONA REPAIRS AND PROTECTS THE FLOOR OF A BATTERY TREATMENT PLANT

ID: 7799

Concrete floor of a battery treatment plant.

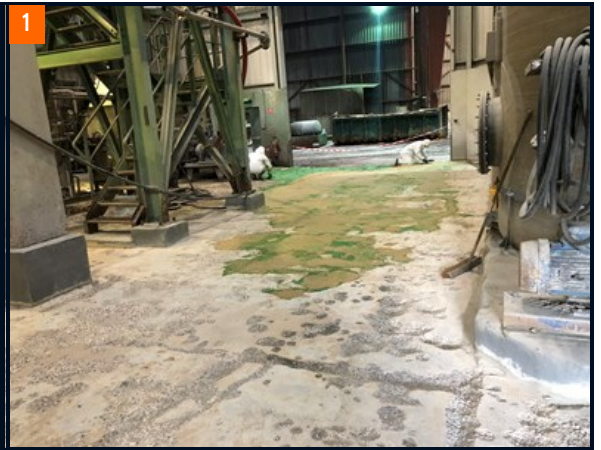
The concrete floor of this battery treatment plant was badly damaged by the acid from the batteries. Around 400 tonnes of batteries are treated each day in this plant and the acid attacked the concrete leading to severe pitting up to 40cm deep.

Before application.

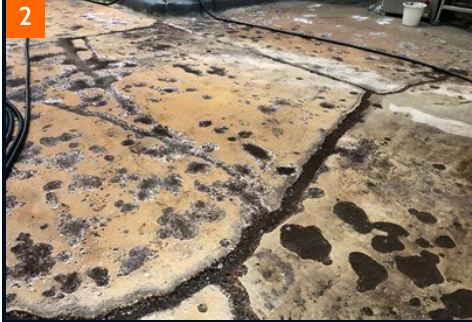
Before application.

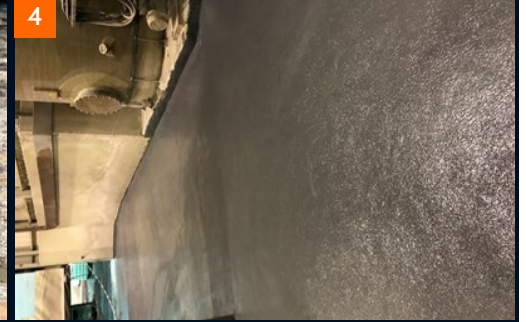
Final application after protection with Belzona 4311.

The floor was first washed and the surface roughened. Then Belzona 4151 was used with silica sand to resurface the whole area and repair the pitting due to the attack of the acid. Finally, Belzona 4311 was used to protect the floor against further damage from the acid. This was completed in accordance with Belzona Know-How System Leaflet FPA-03.
