# BELZONA RECLAIMS RUBBER LINING OF WATER FILTER IN STEAM GENERATOR

ID: 78

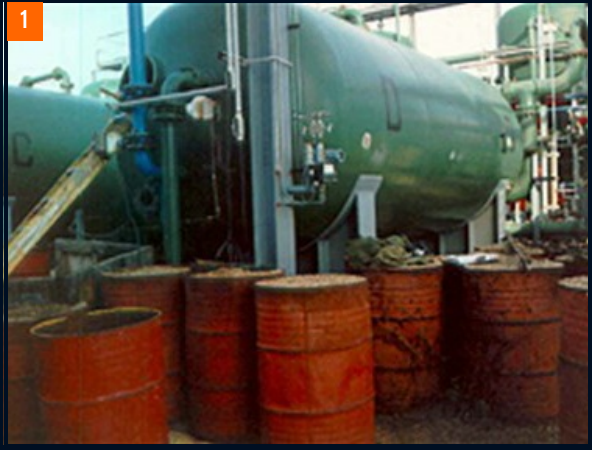
Rubber lined water filter; 6.7m long, 3.5m diameter

1. External view of water filter
2. Preparing the surface of the rubber lining
3. Flange faces repaired

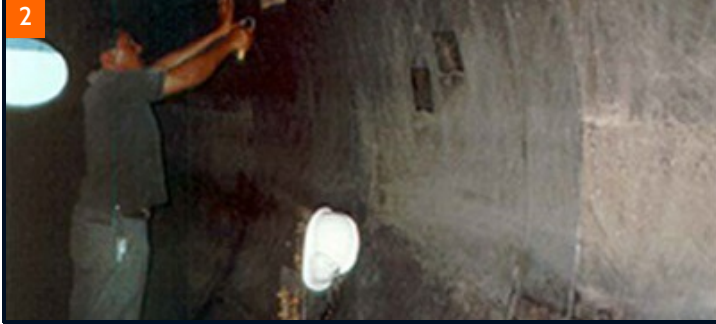
The original rubber lining was cracked, particularly at the points where it was anchored to the substrate. As a result the filter leaked and lost efficiency.

In accordance with Belzona Know-How Leaflets TCC-3 and VPF-13.
