# BELZONA SEALS PROCESS TOWER ROOF

ID: 7801

Aluminium roof of a process tower

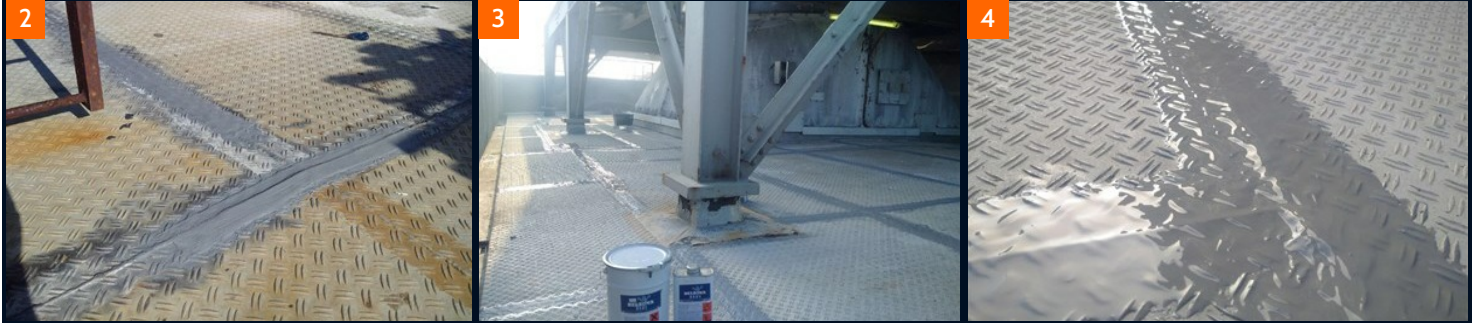
## PHOTOS

The roof of a process tower in this fertiliser plant was leaking due to the chemicals that were attacking the welds. Infiltration of water was becoming problematic for the production and the roof had to be fixed.

Before application  
Sealing step with paste grades  
Final application  
Sealing close up

The previous repairs were removed and Belzona 1111, 1161, 1212 and 9341 (reinforcement sheet) were used to seal the gaps. Then two coats of Belzona 3121 were applied on top of the repairs to seal in accordance with Belzona KNow-How System Leaflet RPA-1.
