# BELZONA REPAIRS AND PROTECTS CHIMNEY MASONRY

ID: 7802

Flue gas chimney stack.

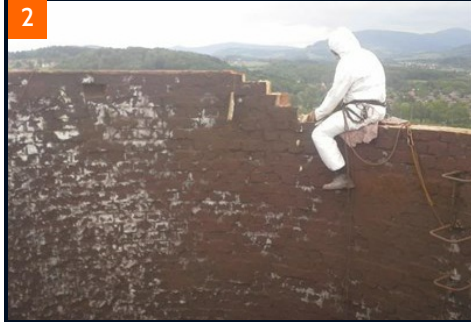
The top of the stack had deteriorated due to flue gas and water ingress, causing the mortar to break down and bricks to become loose.

The deteriorated stack.

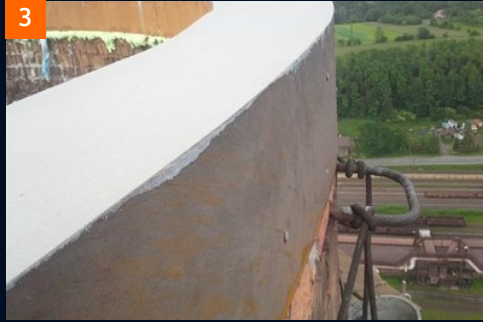
Work underway.

The application was carried out in accordance with a modified version of Belzona Know-How System Leaflet WPA-4. The top profile was reformed with new brickwork and Belzona 4111 using preformed sheet metal formers around the outer and inner circumference as guides. The deteriorated mortar was then repaired using Belzona 4141 due to its lightweight properties allowing repair on vertical surfaces. The whole area was then coated with Belzona 4341 to give long term protection against flue gases.
