# BELZONA REBUILDS AND PROTECTS HEX END BELL AND CAP AT A BEVERAGE FACILITY

ID: 7809

HEX end bell and cap at a juice manufacturing facility.

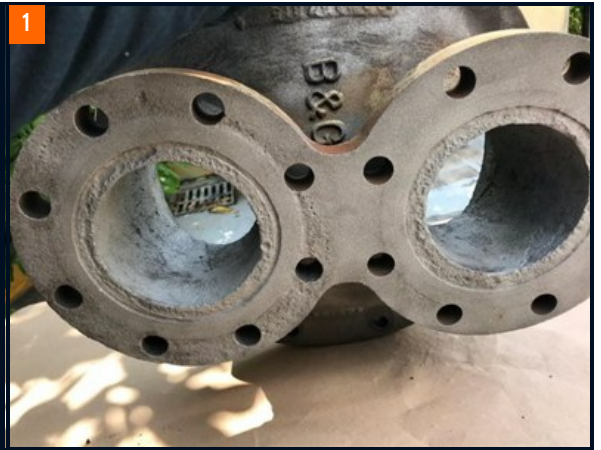
Erosion-corrosion wear caused by having no protective coating before the heat exchanger started its service life.

End Cap after abrasive blasting

The application was carried out in accordance with modified versions Know-How System Leaflets: HEX-2 and HEX-3. Both the end bell and the cap was abrasive blasted to a near white metal finish with an angular profile of 3 mills. Belzona 1511 was used to rebuild the steel substrate for high conditions Belzona 1391T to protect the steel substrate for high heat conditions.

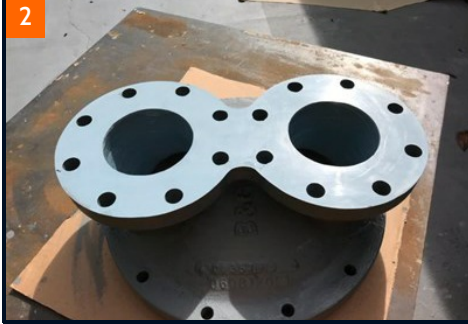
End Cap after application of Belzona 1511 and 1391T

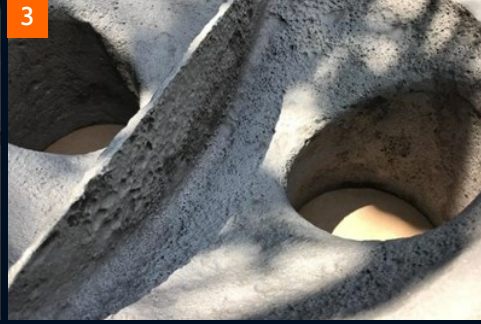
End Bell after abrasive blasting

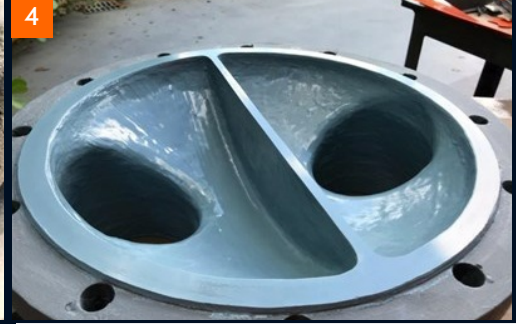
End Bell after application of Belzona 1511 and 1391T
