# HITCH BEARING RE-FIT WITH BELZONA

Top center bearing on Volvo articulated truck.

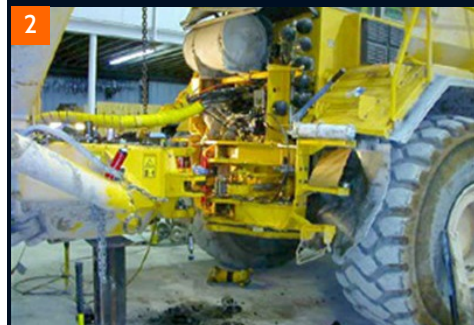
1. View of 40T Articulated truck
2. View of the hitch
3. Top bearing coated with Belzona 1111
4. Both bearings fitted, ready to be coupled to trailer

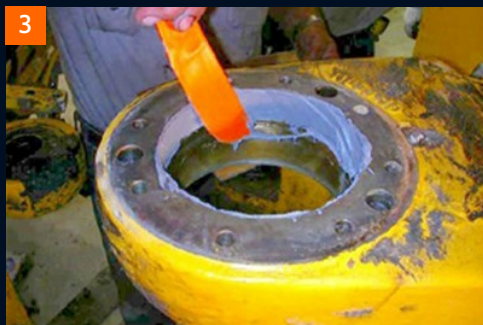
The truck was needed back in service within 12 hours and the broken bearing had damaged the hitch bore.
