# BELZONA COLD PLATE BONDING SAVES A STORAGE TANK'S ROOF

ID: 7810

Roof top of an oil storage tank in a port authority facility.

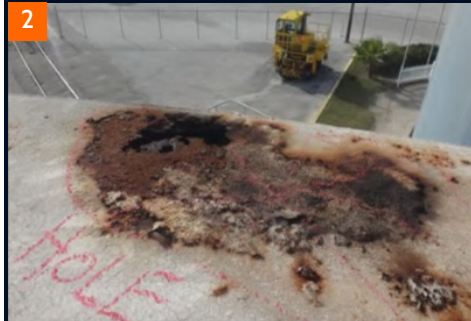
Roof top near edges exhibited thinned metal and through holes.

Tank roof top exhibiting damaged areas

Plates could not be welded to the remaining substrate. Cold plate bonding technique was chosen to cover roof top holed areas. The Customer's contractor removed large thinned sections of the roof top and prepped the remaining substrate by a hand-held grinder. New steel plates had been pre-cut and abrasive blasted to a near white metal finish with a 3 mill angular profile. Belzona 1161 was mixed - the roof top surface had been wetted out with a small 2" cut chip brush. At the same time the remaining mixed material was applied to the bottom of the new steel plates creating a build-up in the center of the plates to allow Belzona 1161 to spread out evenly filling all the voids.

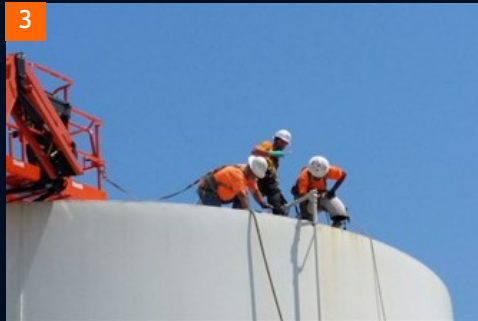
Thinned and holed areas near the edge of the tank roof

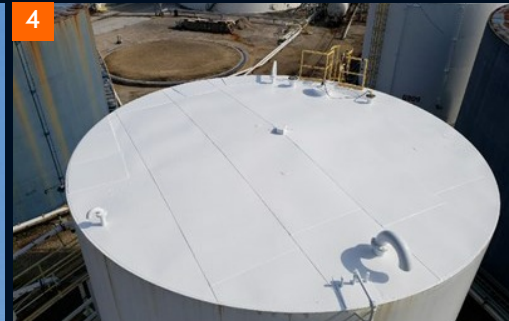
Completed plate bonding
