# BELZONA REPAIRS AND PROTECTS A CORRODED FEEDING PIPE

ID: 7811

Emergency repair on a feeding pipe circulating sulphuric acid into a storage tank.

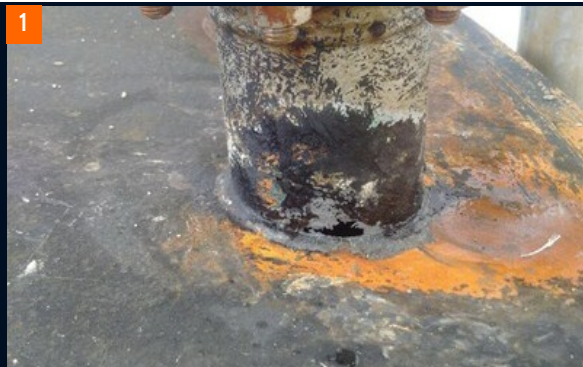
The pipe was perforated due to corrosion and sulphuric acid was leaking out.

Before application.

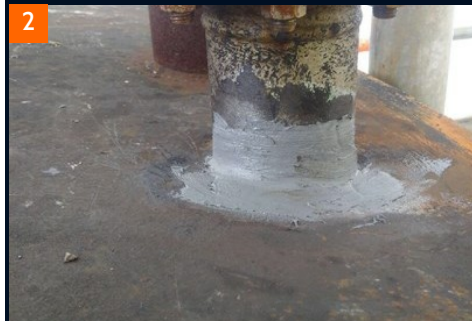
After Belzona 1212 to plug the leak.

The leak was plugged with Belzona 1212 in order to secure the pipe. The surface was then manually prepared and Belzona 4341 was used with a reinforcement sheet all around the pipe to reinforce its structure and protect it against acid, in accordance with Belzona system leaflet VPF-11.

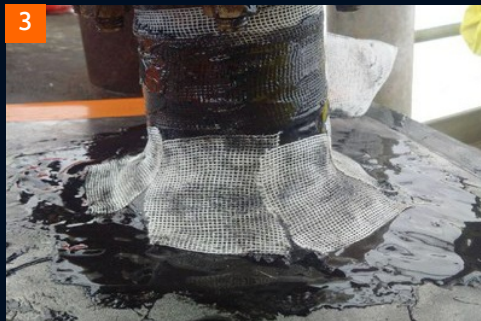
Belzona 4341 applied with reinforcement sheets.

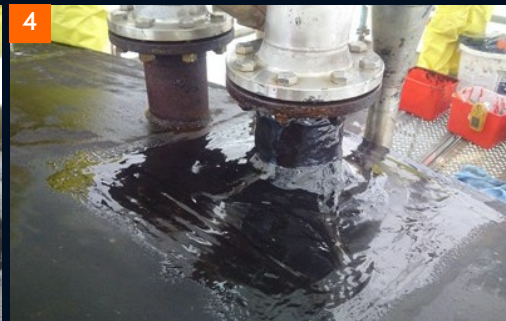
Final application.
