# H2S DAMAGED LIFT STATION REBUILT AND PROTECTED WITH BELZONA

ID: 7812

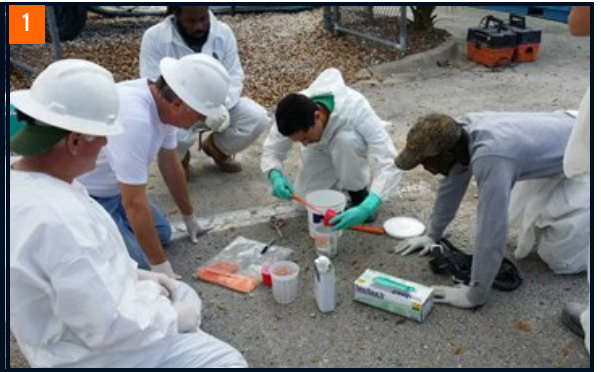
1. Training of the application crew.
2. Technicians applying Belzona 4911.
3. Application of Belzona 4131 (Magma-Screed).
4. Final coat of Belzona 5811.
