# BELZONA REPAIRS AND PROTECTS AN OLD VACUUM PUMP TRUCK

ID: 7813

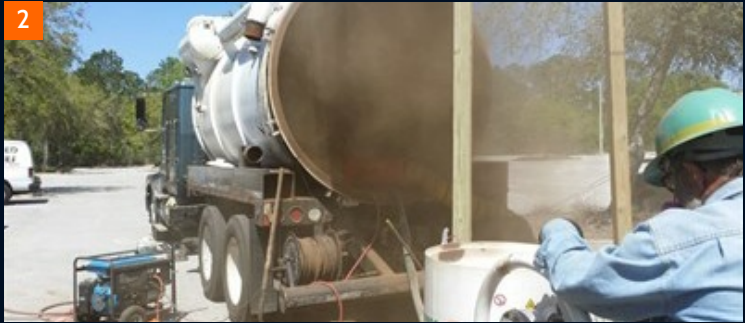
2

Main tank of the vacuum pump truck had no previous protective coating. The steel substrate inside had exhibited small through pin holes and was severally corroded.

1. Surface preparation by blasting.
2. Blasting of the inside of the vacuum truck.
3. Completed internal lining with Belzona 5821

Application was carried out with a modified Know-How System Leaflet TCC-5. Blast cleaned the steel to achieve the American Standard near white finish SSPC-10 with an angular profile of 3 mils. Cleaned and scrubbed with a salt cleaning solution to remove salt contaminants and tested for the minimum level of chlorides. Re-blasted the substrate to remove surface flash rust before application. Applied Belzona 1212 combined with a reinforcement sheet to cover pinholes, and applied Belzona 5821 as a protective coating.
